Manhole Inspection Summary

Manhole # S09OO_005MH

Location Address: **2531 DENISON AVE**

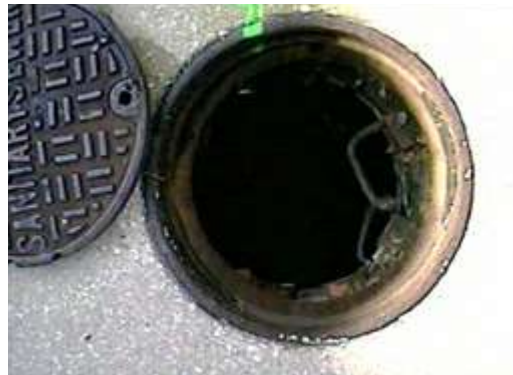
Defect 2

Condition: ☐ Sound ☐ Cracked ☐ Root Intrusion ☒ **Loose Brick** ☒ **Deteriorated**

LOOSE BRICKS AND DERE

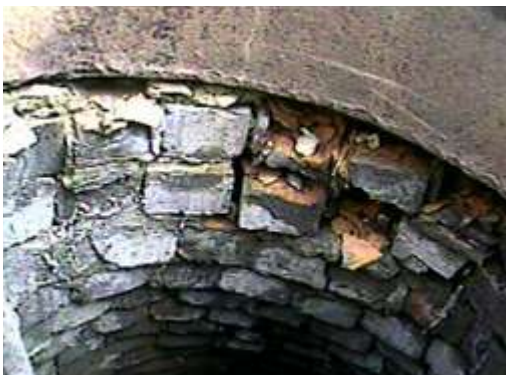
Defect 1

LOOSE BRICKS AND DETERIORATED
ADJUSTMENT

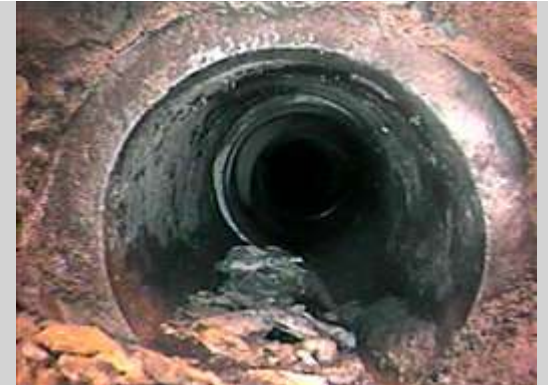
12 O'Clock Outflow

8 in. Circular Gravity Sewer
Pipe Out @ 12 O'Clock

Deposits: ☐ None ☐ Mud ☐ Sludge ☒ **Debris** ☐ Grease

Silt Depth: **2** (in.) Deposits Extent: **Light**
